2005 Annual Inspection Report for the Weldon Spring, Missouri, Site

February 2006

U.S. Department
of Energy

Office of Legacy Management

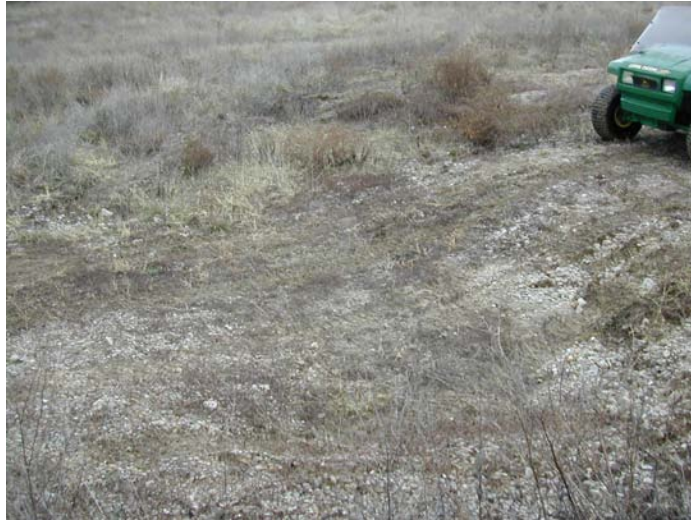
Approximately one week after the official inspection, a depression area was noted in the prairie approximately 150 feet from the disposal cell on the north side (Photo 1). The location of the depression is shown in Figure 4. It was determined this was an area of past trenching and is most likely settlement caused by inadequate compaction of the soil at the completion of trenching. The area will be evaluated to determine the best course of action to address the area.

Photo 1. Depression area in the prairie east of the disposal cell.

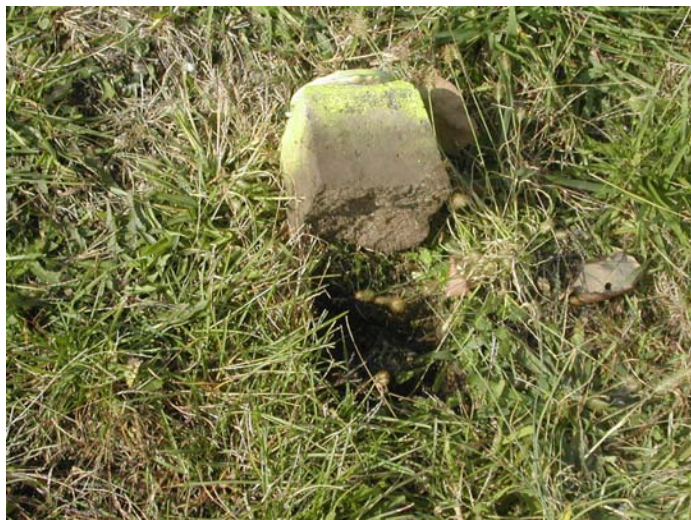
1. **Finding:** The boundary monument WS-46 was broken off.

Photo 3. Groundwater restriction boundary WS-46. Monument has been broken off.

Corrective Action: Coordinate repair of the monument.

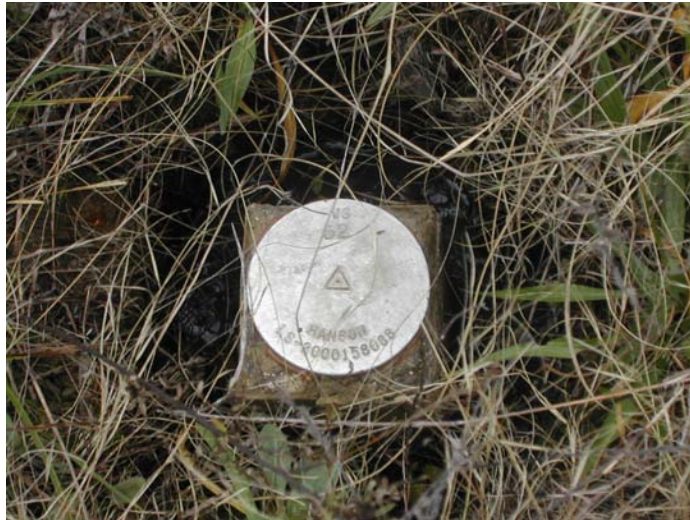
Photo 4. Groundwater restriction boundary monument WS-52. Has been dug around sides.

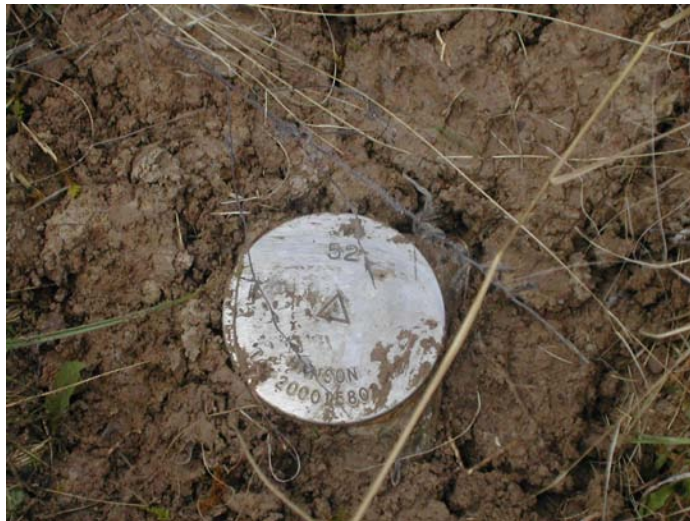
Photo 5. Groundwater restriction boundary monument WS-52. Dirt was replaced around monument.

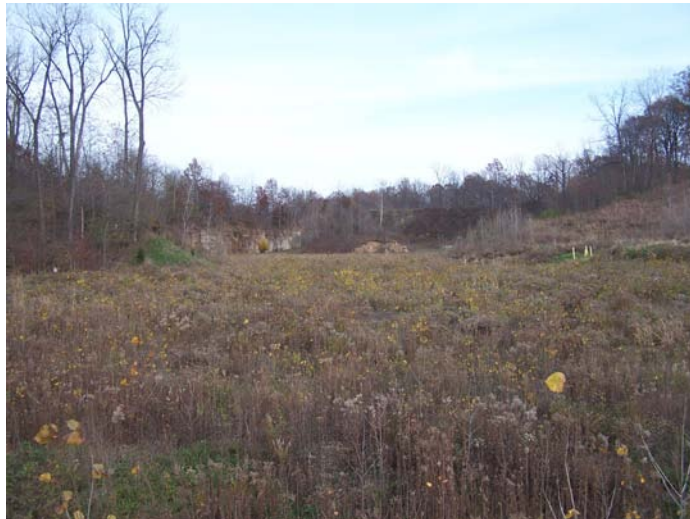
Photo 6. The Quarry viewed from the Hamburg Trail. Note the successful revegetation and numerous tree samplings

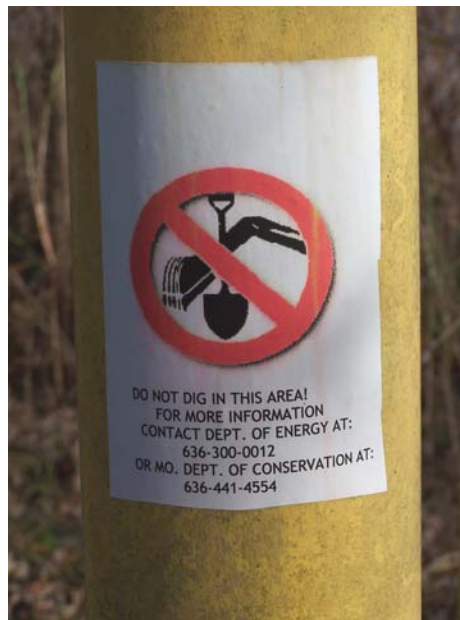
Photo 7. A “No Excavation” warning sign at the leachate sump area.

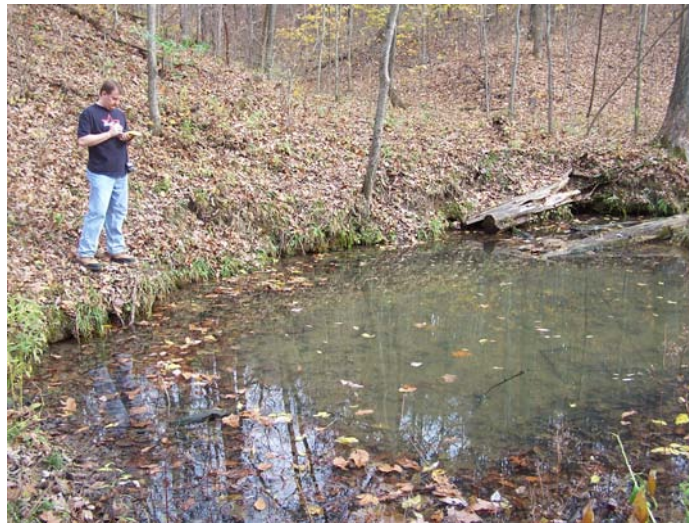
Photo 8. Spring SP-5304 in the Southeast Drainage.

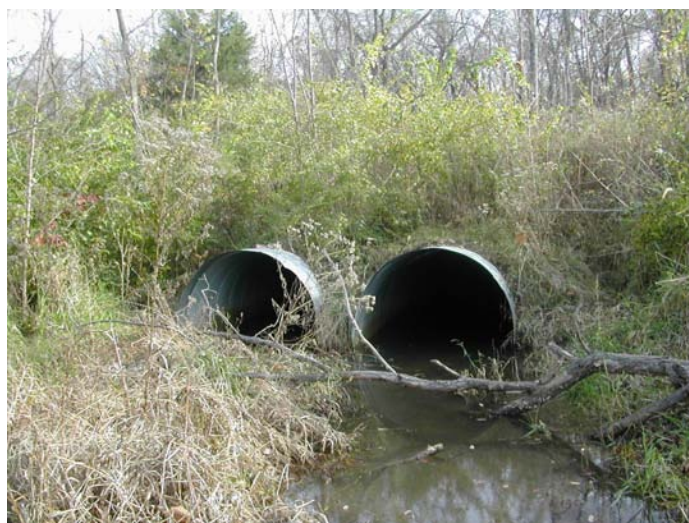
Inspection Results: The Highway D culverts were inspected (Photo 9). During the 2003 and 2004 annual inspection the area where the outlet side of the culvert passes beneath the ditch between Highway D and the north end of the culvert had eroded on top, exposing the culverts. The Missouri Department of Transportation (MoDOT) had been notified of this condition and been sent a copy of the inspection reports. Prior to the 2005 inspection, MoDOT had been in contact with the site and stated that they were going to address the culvert. They later contacted the site and stated that they had placed gravel on the culvert. It was noted during this inspection that gravel had been placed on top of the area covering the exposed culverts (Photo 10). This effort appears to have stabilized the areas so as to minimize additional erosion. Concrete had also been placed on the outside and middle of the culverts on the inlet side to minimize erosion in those areas (Photo 11).

Photo 9. Outlet end of Highway D Culverts.

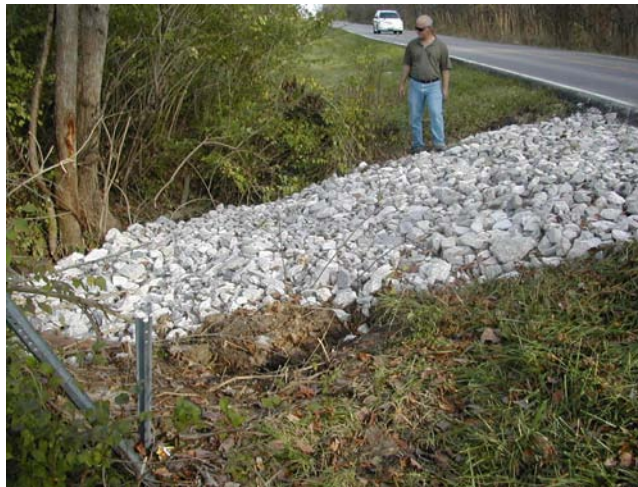
Photo 10. Gravel repair to Highway D Culverts.

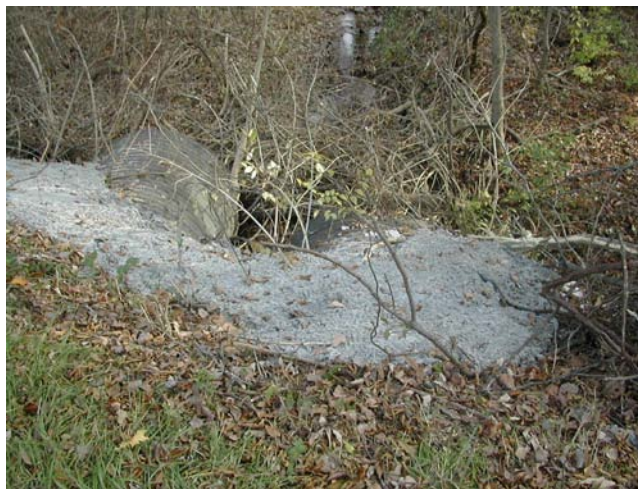
Photo 11. Inlet side of Highway D Culverts. Concrete had been placed on outside and in the middle of culverts.

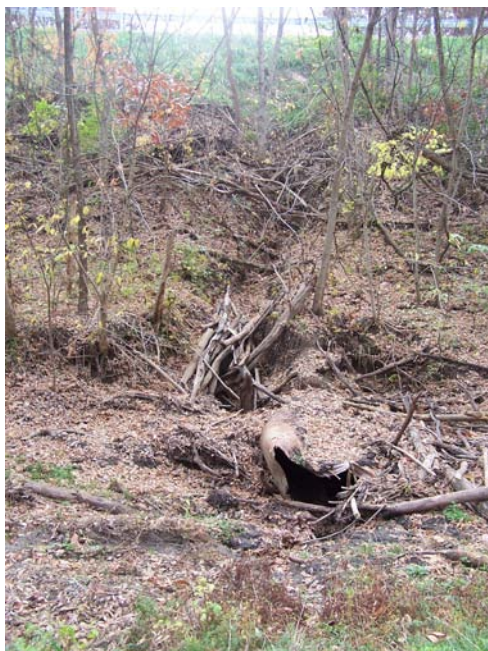
Inspection Results: The State Route 94 culvert was inspected. During the 2003 and 2004 inspections the upstream end of the culvert was substantially blocked with debris. The MoDOT had also been notified of this condition. During the 2005 inspection it was noted that the area had been cleared of debris (Photo 12).

Photo 12. Highway 94 culvert inlet in the Southeast Drainage.

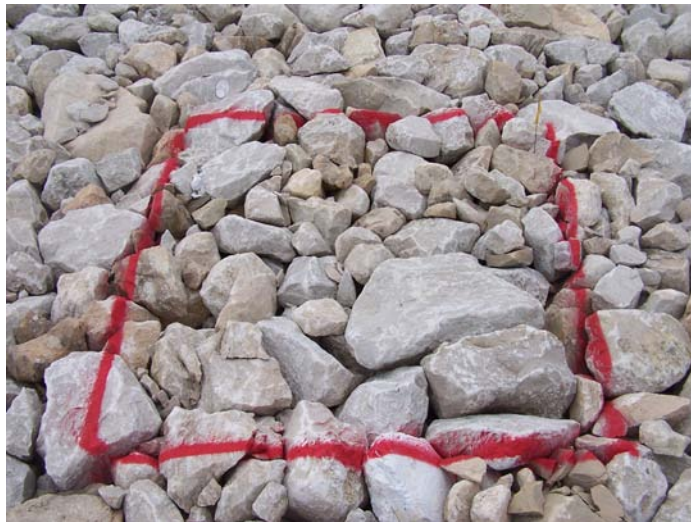
The disposal cell was inspected in accordance with the LTS&M Plan and the annual inspection checklist. The cell was divided into ten transects ([Figure 7](#)). The inspectors separated into two groups and walked five transects each; one group also walked along the grade break at the top of the side slopes and along the cell perimeter. The inspectors looked for depressions, shifts of cell plane vertices, and other indications of settlement. Other items for inspection were vegetation, wet areas, apron drains, guardrail, and the stairs. A GPS unit was used during the 2003 inspection to map five areas chosen for rock degradation review ([Figure 7](#)). The inspectors took photographs of these and compared them to photographs from the previous inspection of the same areas and observed no rock degradation. These areas are shown in Photos 13 through 17.

Photo 13. Cell cover rock test plot TP1; north edge of north facet.

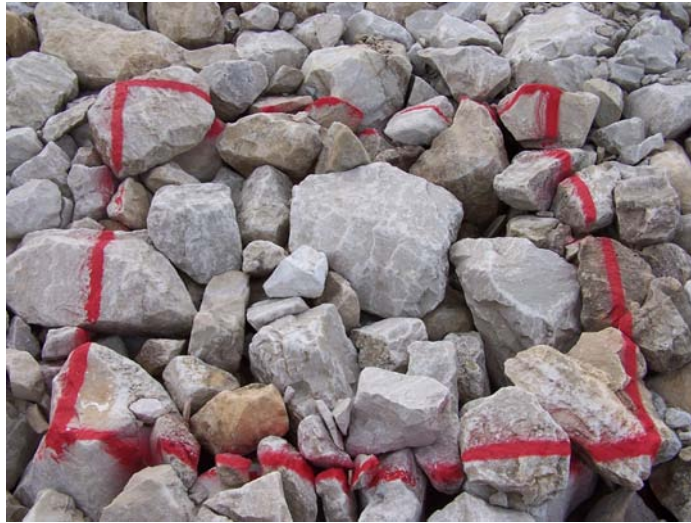
Photo 14. Cell side slope rock test plot TP2; bottom of north side slope.

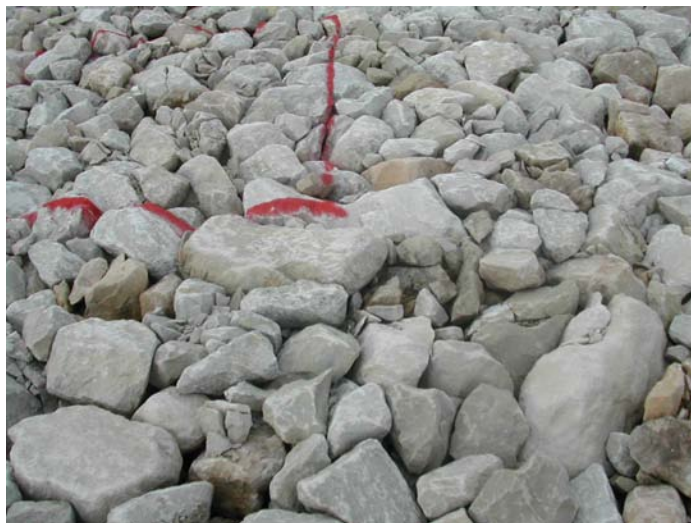
Photo 15. Cell cover rock test plot TP3; northeast ridgeline.

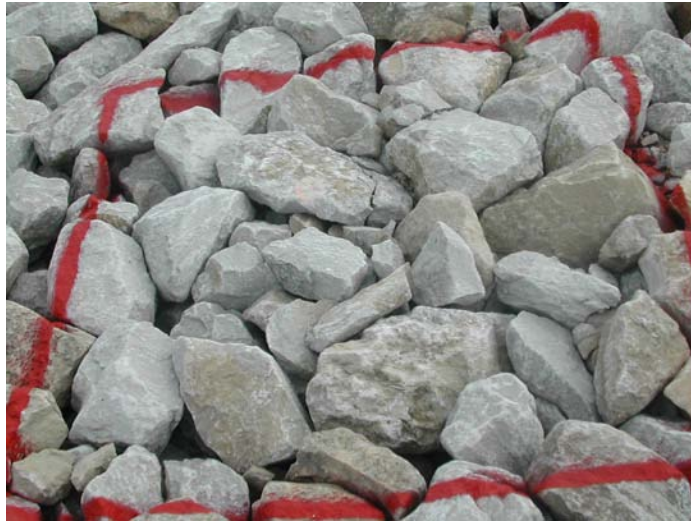
Photo 16. Cell cover rock test plot TP4; lower west side slope.

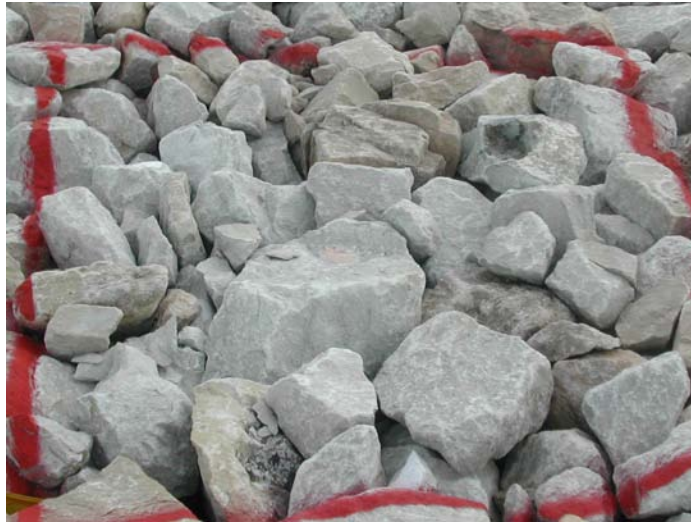
Photo 17. Cell cover rock test plot TP5; located on upper west side.

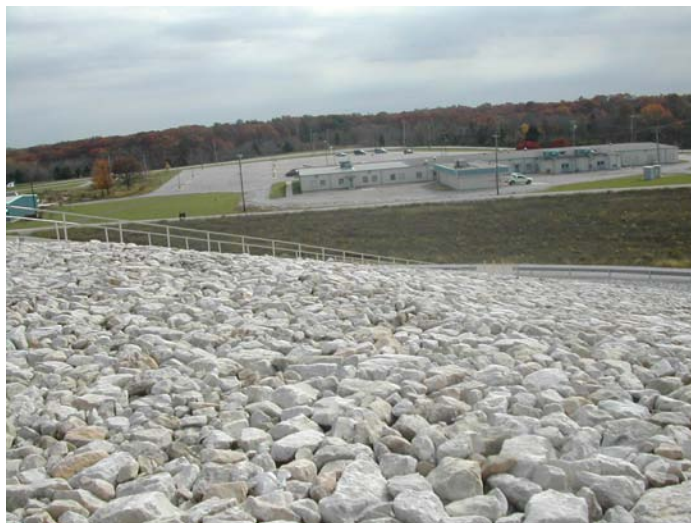
Photo 18. View from top looking SW towards admin bldg. Slight bulge.

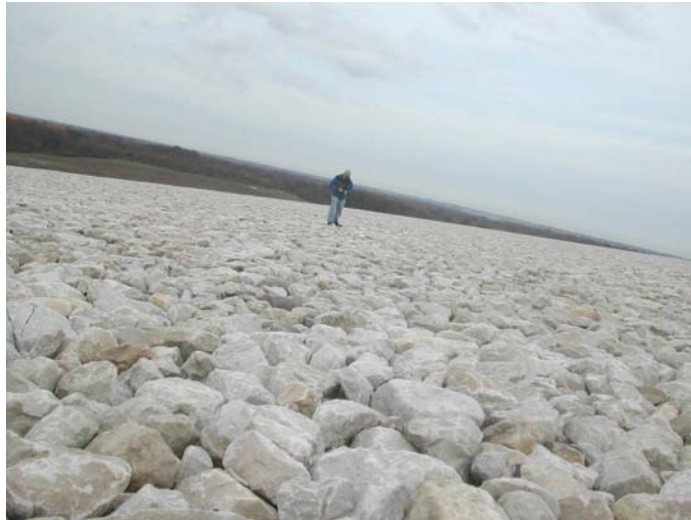
A few small shallow depressions on the cell cover and along the grade break were noted during the inspection. It appeared that the depressions ranged up to approximately 2 or 3 inches deep. The majority of these areas had been identified during the previous inspection(s). A few additional areas were noted on the northeast and southwest corners of the cell (Photo 18). The area identified as a depression by the aerial survey was located by GPS and it was observed that a slight depression exists in this area (Photo 19). These slight depressions are not unexpected for a disposal cell of this type and are not a cause for concern. They will continue to be monitored.

Photo 19. Slight depression area shown on aerial survey on southwest side looking northwest.

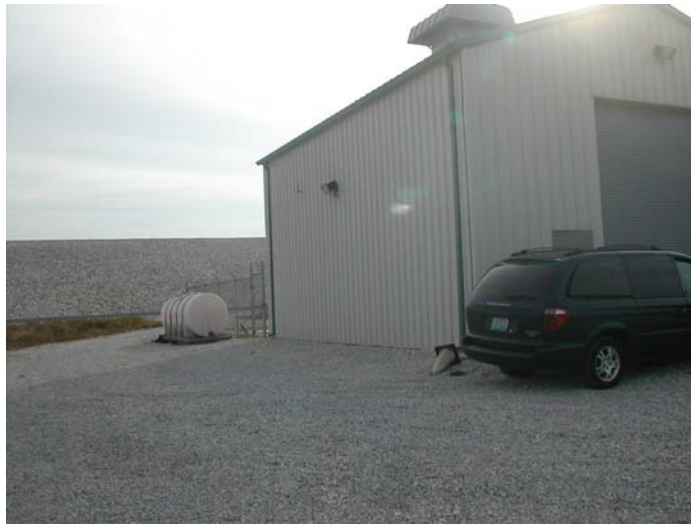
Operations of the LCRS were discussed with site personnel and the system was inspected (Photo 20). The fences and doors were locked and in good condition. The system was functioning as designed. The LCRS data and documentation were reviewed during the document review period of the inspection and the following information was checked and verified that it was available: sampling data, LCRS flow rates, action leakage rate information, "burrito" system flow rates, and leachate data. As required by the LTS&M Plan, the leachate production rates, analytical results, and disposal information are provided in [Appendix C](#).

Photo 20. Outside Train 3 LCRS Building.

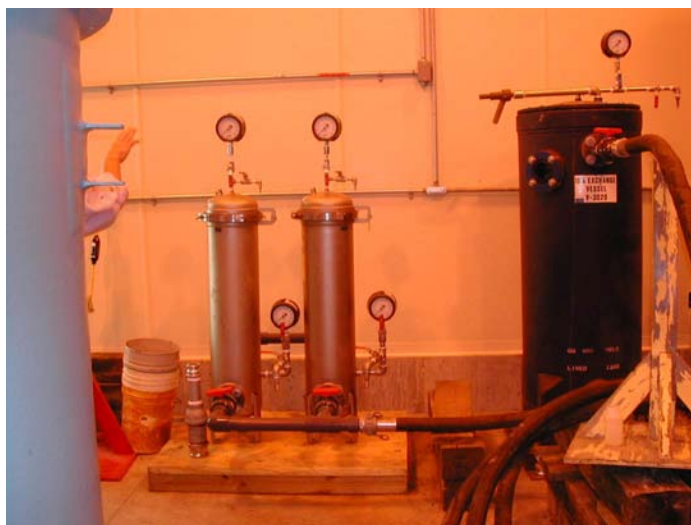
The DOE continues to exercise its pretreatment contingency process equipment by pretreating the leachate through a system of cartridge filters and ion exchange media that is selected for uranium (Photo 21). The leachate is sampled and continues to be well below the limit for uranium. The leachate will continue to be managed in this manner until the leachate is consistently below the 20 pCi/L level for uranium.

Photo 21. Ion Exchange system for leachate treatment.

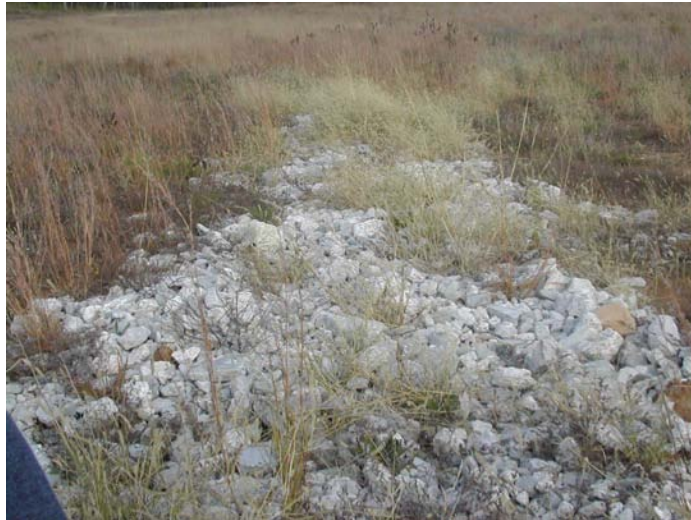
During the 2004 inspection, erosion areas were identified on the north and northwest sides of the disposal cell. These areas were repaired during June 6-8, 2005. A total of 32 rock boxes were constructed to prevent erosion from continuing. These rock boxes were filled with 2-inch rock and topped with 3-6 inch rock to ensure the rock would stay in place during high precipitation events. An additional 17 loads (approximately 255 tons) of 3-6 inch rock was delivered and

placed in the ditches/swales. The filled ditches provide well-drained channels for water to flow freely and no additional erosion should occur (Photo 22). A discussion of the repairs was held during the inspection and a few of the areas were inspected and found to be in good condition.

Photo 22. Erosion control repairs.

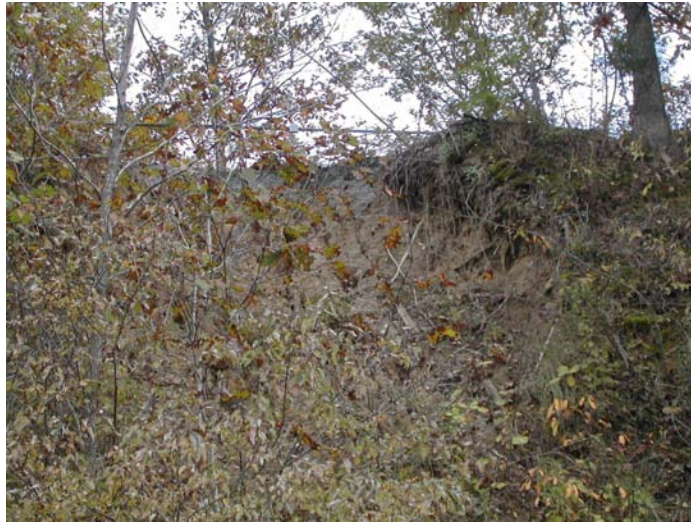
Erosion areas were observed along some of the high walls of the Quarry during the inspection (Photo 23). These areas will continue to be monitored in the future.

Photo 23. Walls of Quarry Proper.

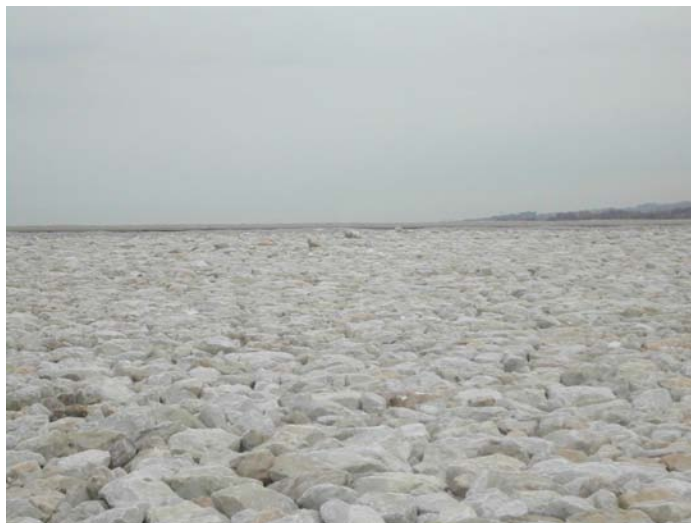
Photo 24. Rocks disturbed on top of cell.

Remarks Minor rock displacement at the top of the disposal cell.
Bronze plaques at top of cell have been scratched. In July 2005,
historical marker #10 was found to be vandalized and was
replaced.

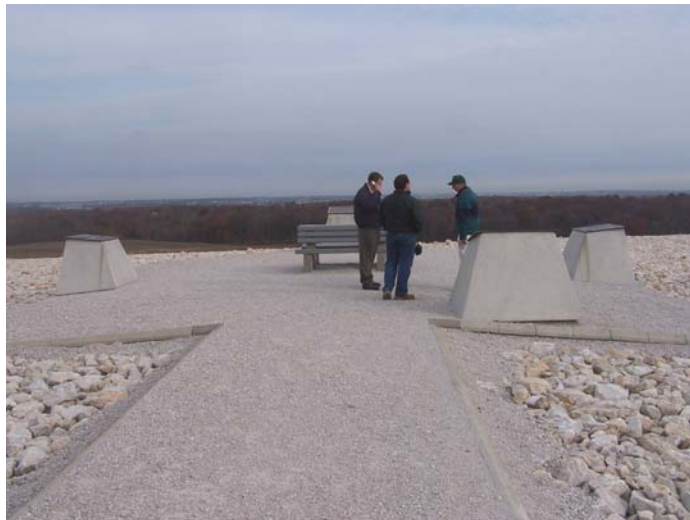
The four information plaques on top of the cell were generally in good condition. The faces of the bronze plaques have been scratched and a repair kit was purchased to repair the scratches. The pedestal on the south side of the viewing platform was eroded under the southeast corner (Photo 25). The historical markers were inspected prior to the inspection on October 27, 2005, and found to be in good condition. Photos were taken of each marker. Marker #3 is shown in Photo 26.

Photo 25. The platform and markers on top of the disposal cell.

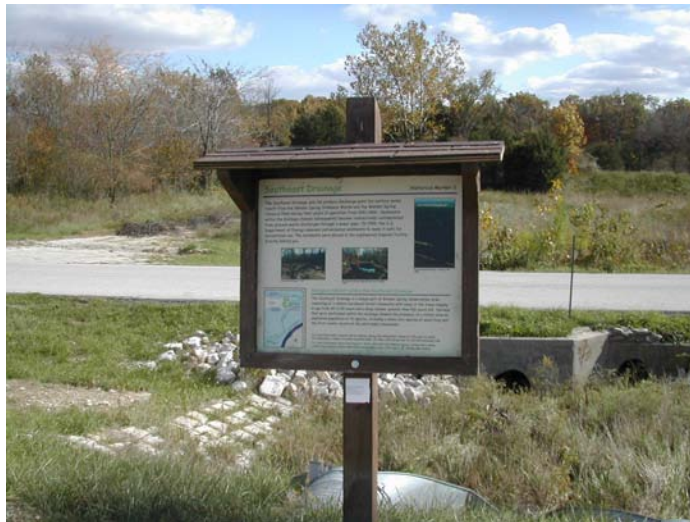
Photo 26. Historical Marker #3.

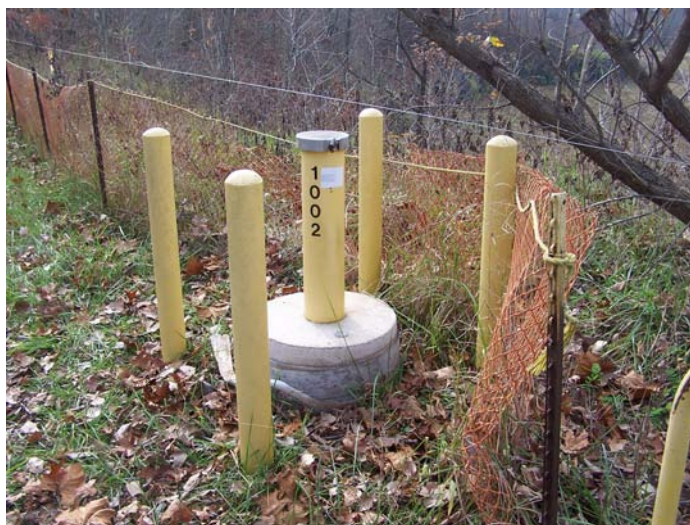
Monitoring wells in the Disposal Cell Monitoring Well Network, Chemical Plant Monitoring Well Network, and Quarry Monitoring Well Network were inspected (Photo 27). The inspection checklist required all the disposal cell wells to be inspected and greater than 10 percent of the Chemical Plant and Quarry wells to be inspected. Each of the 119-groundwater monitoring wells was inspected as a function of the 5-year review inspection. Some of the wells were inspected in the weeks prior to or after the inspection. Each well was photographed and recorded. The checklist required the wells to be inspected to ensure they are properly secured and locked, in good condition, and to check if they need maintenance and have the proper ID number on the well. All of the wells met these requirements. It should be noted that each well is at least inspected quarterly during the year when static water levels are recorded. The wells are listed below for identification purposes.

Photo 27. Monitoring well MW-1002 on the Quarry rim.
